2011 Tsunami in Tohoku, Japan: Planning and Design of Vertical Evacuation Buildings

- M_w 9.0 11th March 2011 Tohoku earthquake and tsunami damage
- Performance of tsunami protection
- Vertical evacuation buildings – a case study for Yamamoto
- Key lessons to be learned

EEFIT-Tohoku Mission

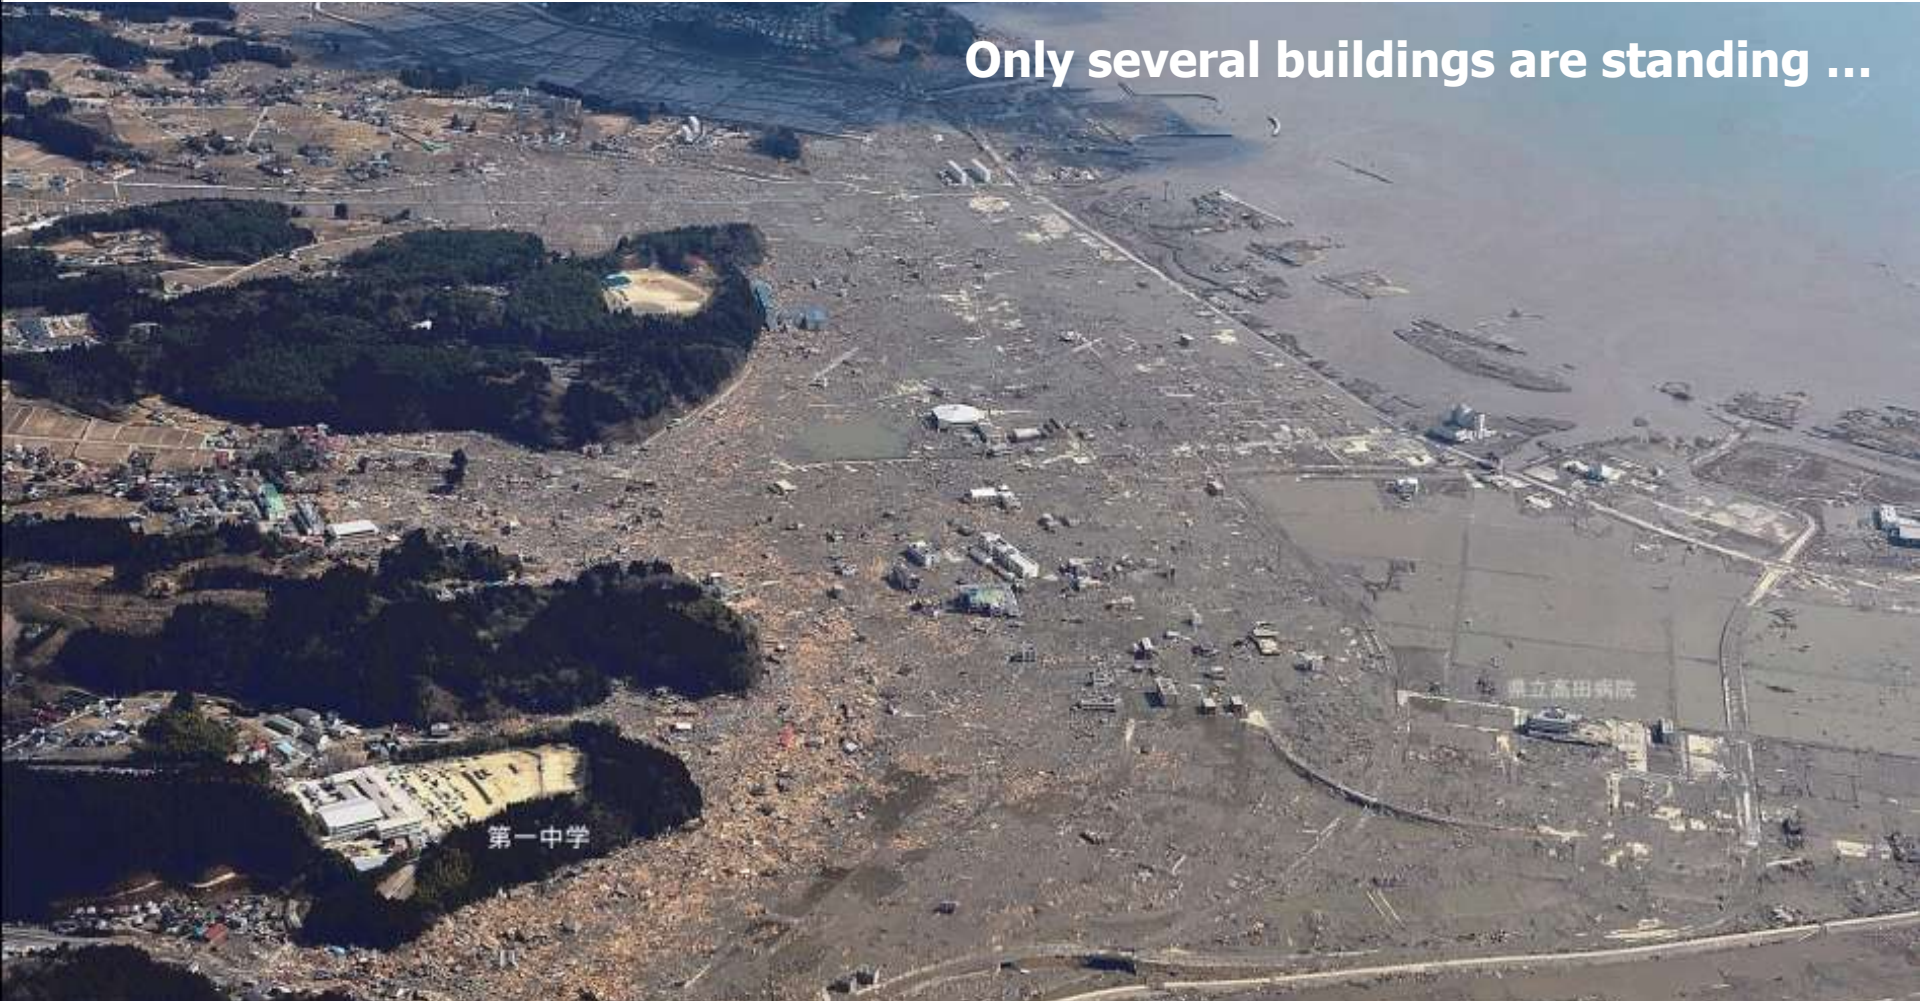
Rikuzen Takata

Only several buildings are standing ...

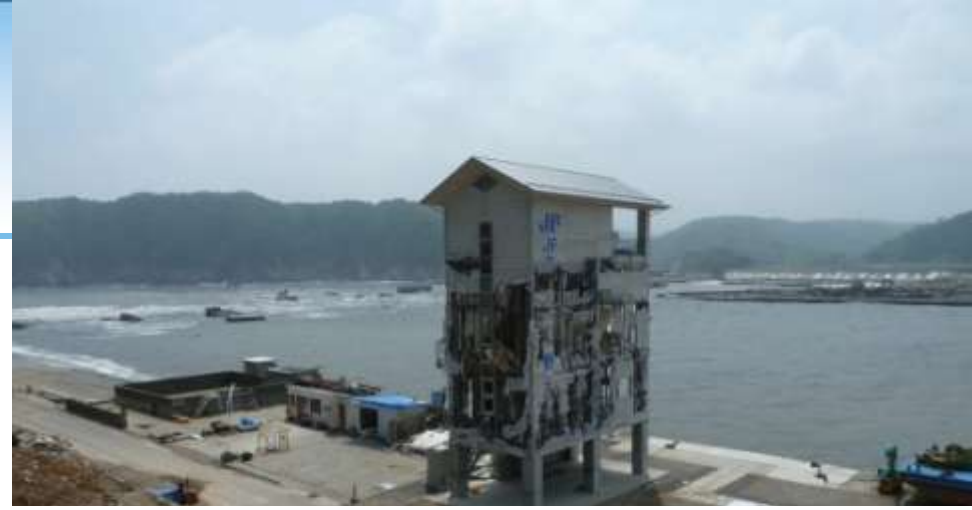
Taro

- 10-m high walls over 2 km – a well-protected town against tsunami – did not protect the

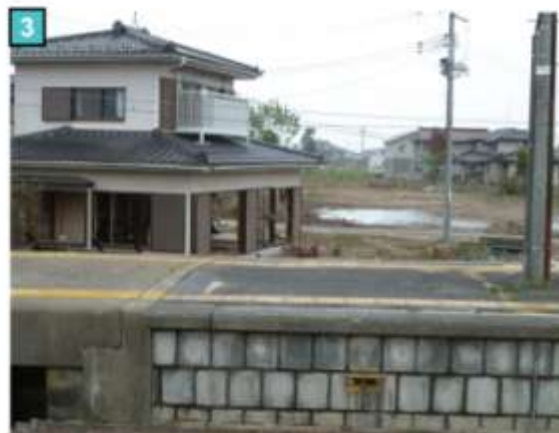
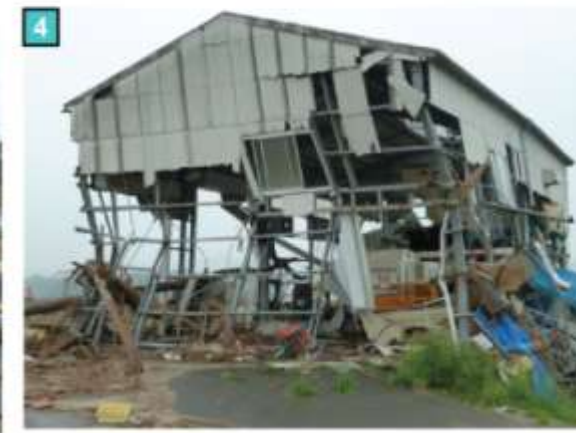
Failure of cross section →

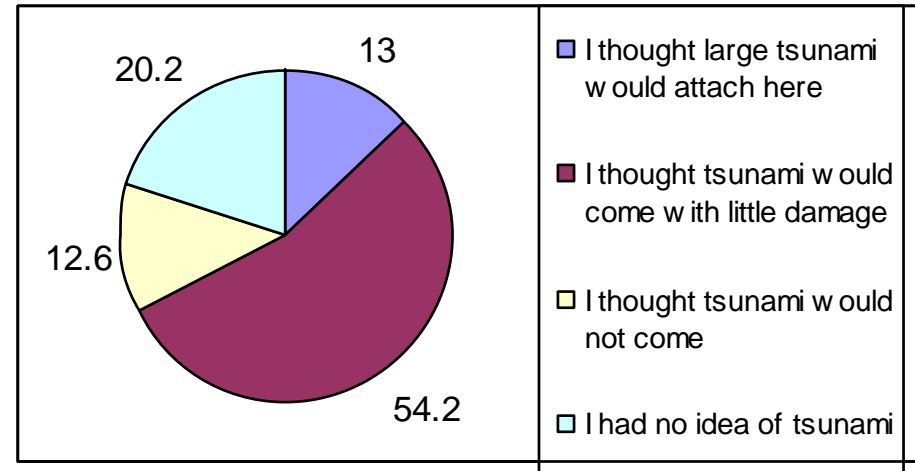
Awareness for tsunami risk

- Post-tsunami survey was conducted in Natori by Murakami et al. (2012)
- Tsunami warning was heard through: radio, TV, municipalities/police
- Use of cars

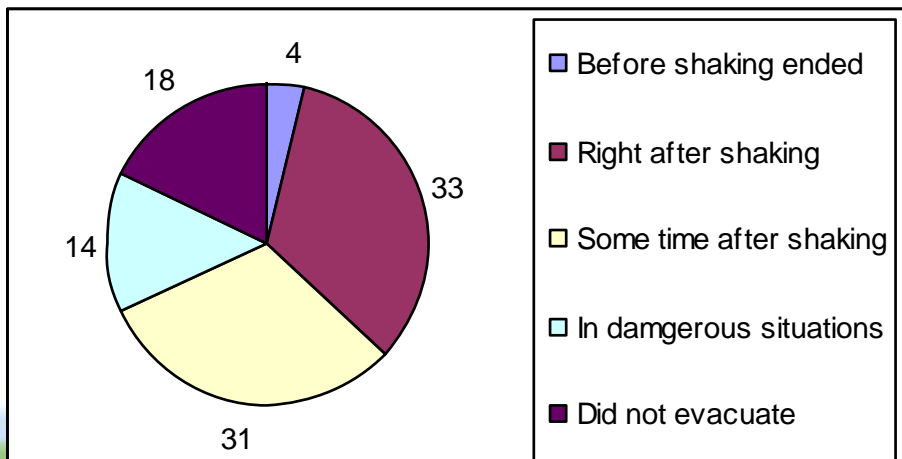
Timing of evacuation

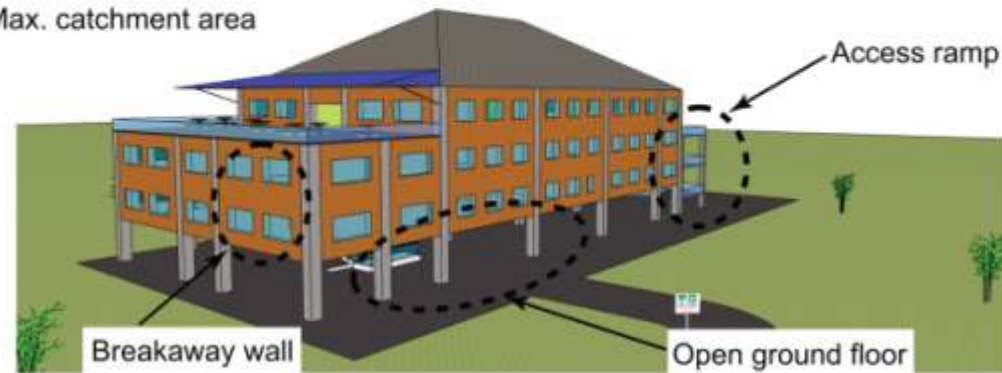
Case Study for Yamamoto (4)

- 500 m radius primary catchment and extended catchment
- Open ground space, breakaway walls
- Structural design: lateral forces and pile foundation
