# Environmental Testing on Composites Overwrap Repairs : Effects of Curing on Durability

# S H Mohd Ramli\*, F Ahmad+, Z Man+, K H Leong\* — \*PETRONAS Group Research, +Universiti Teknologi PETRONAS

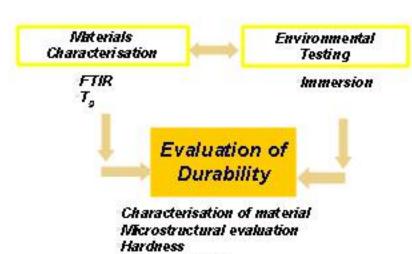
Fig. 2. Illustration of project flow chart summarizing experimental design.

The samples are subjected to immersion in natural seawater up to 312 hours (44 days) and is periodically evaluated at intervals of 2-3 days. The test temperature is maintained at ambient temperature.

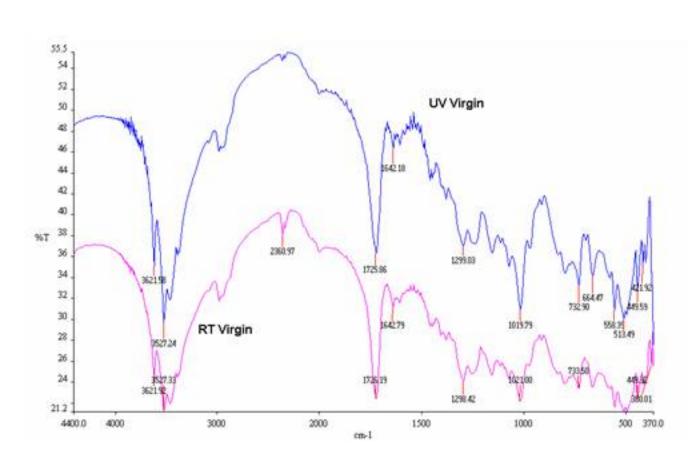
Fig 3a FTIR spectrums of virgin (unexposed) UV- and RT-cured samples

FTIR analysis on the unexposed samples showed that there is a difference in intensity of the spectrums of the UV-cured and RT-cured specimens. However, upon initial immersion tests, the spectrums were observed to be similar for both sets of samples. This indicates that the UV-cured sample did not undergo any change upon immersion, but the RT-cured sample had a change in the intensity and the spectrum was now similar to that of the UV-cured specimens as shown in Fig 3b. However, upon prolonged immersion (312 hours), a change was again observed in the RT-cured sample as the intensity of the spectrum had decreased as seen in Fig 3c. The UV-cured spectrum remained the same after 312 hours immersion.

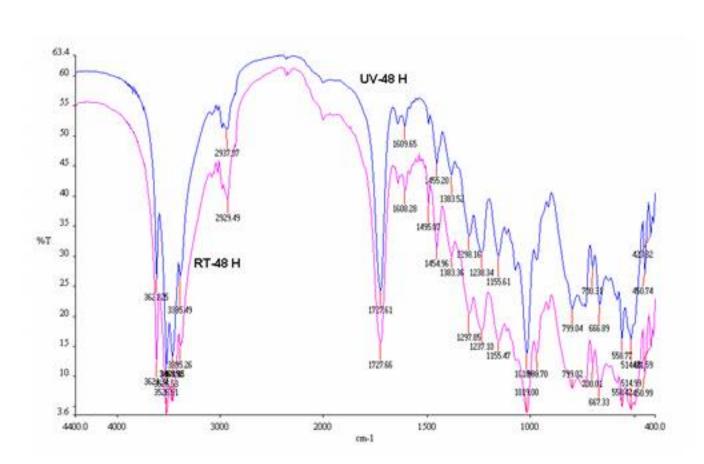
Fig 3b FTIR of the UV- and RT-Cured samples after 48 hr exposure in seawater

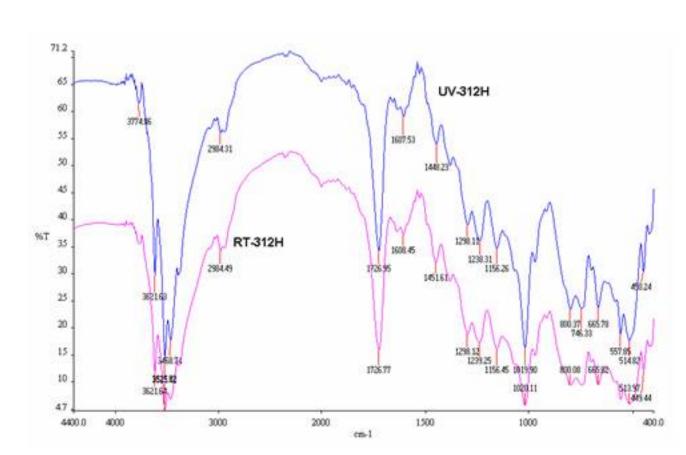
Fig 3c FTIR of the UV- and RT-Cured samples after 312 hr exposure in seawater indicated some changes between the two differently cured samples

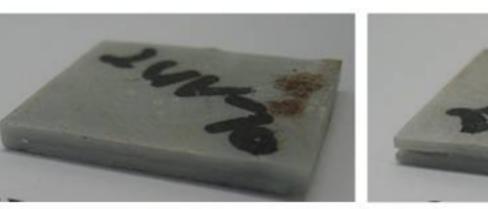
Fig 4a: 2-layer UV cured sample Fig 4b: 2-layer RT cured sample after 144 hours seawater exposure after 144 hours seawater exposure

The specimens were taken out of the chamber and the weight difference were recorded after 48 hours (as shown in Table 1) up to 312 hours. Visual observation also showed no apparent change in colour of the material in both sets of samples. However, some slight material loss had been observed in the RT cured specimens as early as after 144 hour exposure as seen in Fig 4b.

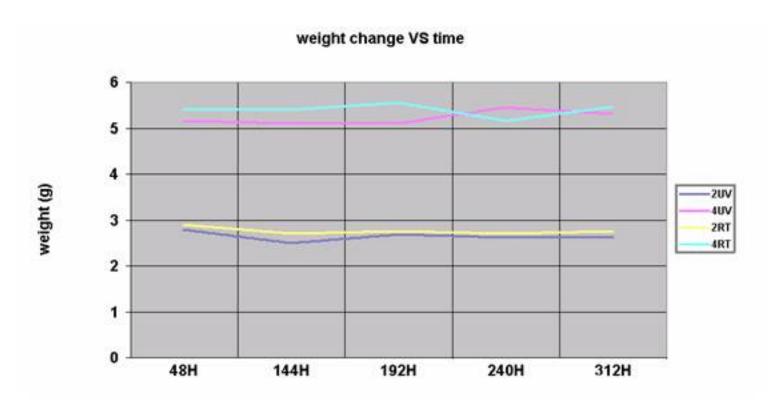
Fig 6: Weight change trend after 312 hours exposure

The weight change of the samples were observed to be very little even after 312 hours immersion, and similar observations were recorded for both the UV-cured and the RT-cured samples as seen in the graph shown in Fig. 6.

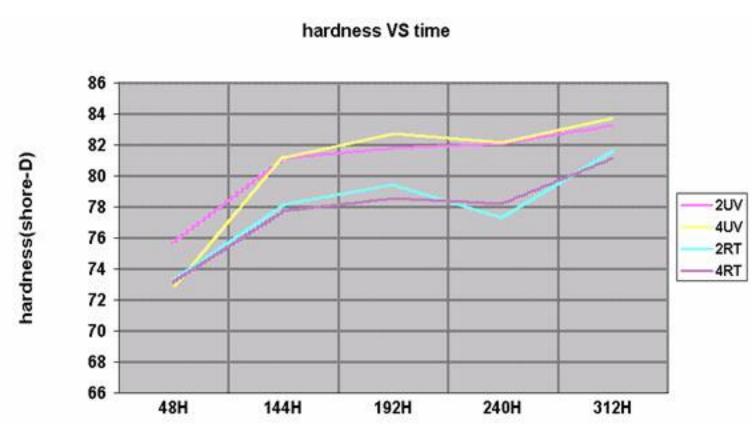
Fig 10: Hardness trend after 312 hours exposure

The hardness values of the exposed samples revealed a similar trend whereby all samples experienced an increase in hardness values after 312 hours exposure, and this was observed both in the 2 layer samples and 4-layer samples. Figure 7 shows the trending of the hardness, whereby a increase in value is seen after 48 hours exposure onwards.

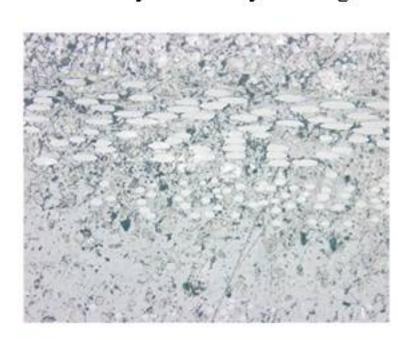
Fig 8a Micrograph of RT-cured sample before immersion (2layer) at 10x magnification

Microscopical examination of the cross-section of the samples were taken before and after immersion, for both the RT-cured and UV-cured samples. The examination revealed that no significant change was observed in the microstructure of the samples, either in the RT-cured or the UV-cured samples, for both 2 layer and 4 layer configuration., as shown in Figures 8 and 9.

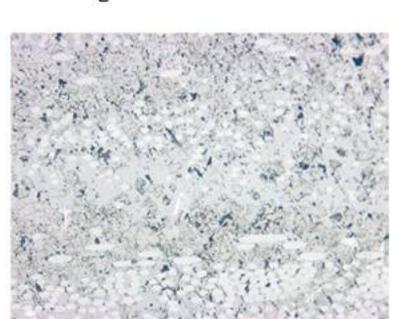
ole Fig 8b Micrograph of UV-cured sample before immersion (2layer) at 10x magnification

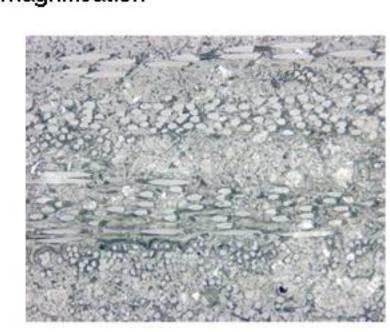
Fig 9a Micrograph of RT-cured sample after immersion (2layer) at 10x magnification

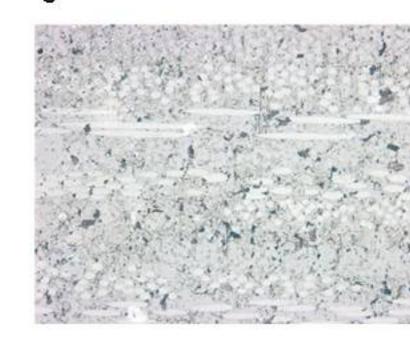
r Fig 9b Micrograph of UV-cured sample after immersion (2layer) at 10x magnification
